**DESIGN ANALYSIS REPORT  
FOR  
VILLAGE OF TULAROSA  
SUPPLEMENTAL WATER SUPPLY**

**FEBRUARY 2025**

Prepared for:  
**VILLAGE OF TULAROSA  
705 ST. FRANCIS DR.  
TULAROSA, NEW MEXICO**

**425 S. TELSHOR BLVD  
SUITE C-103  
LAS CRUCES, NM 88011  
PROJECT NO. 20230413**

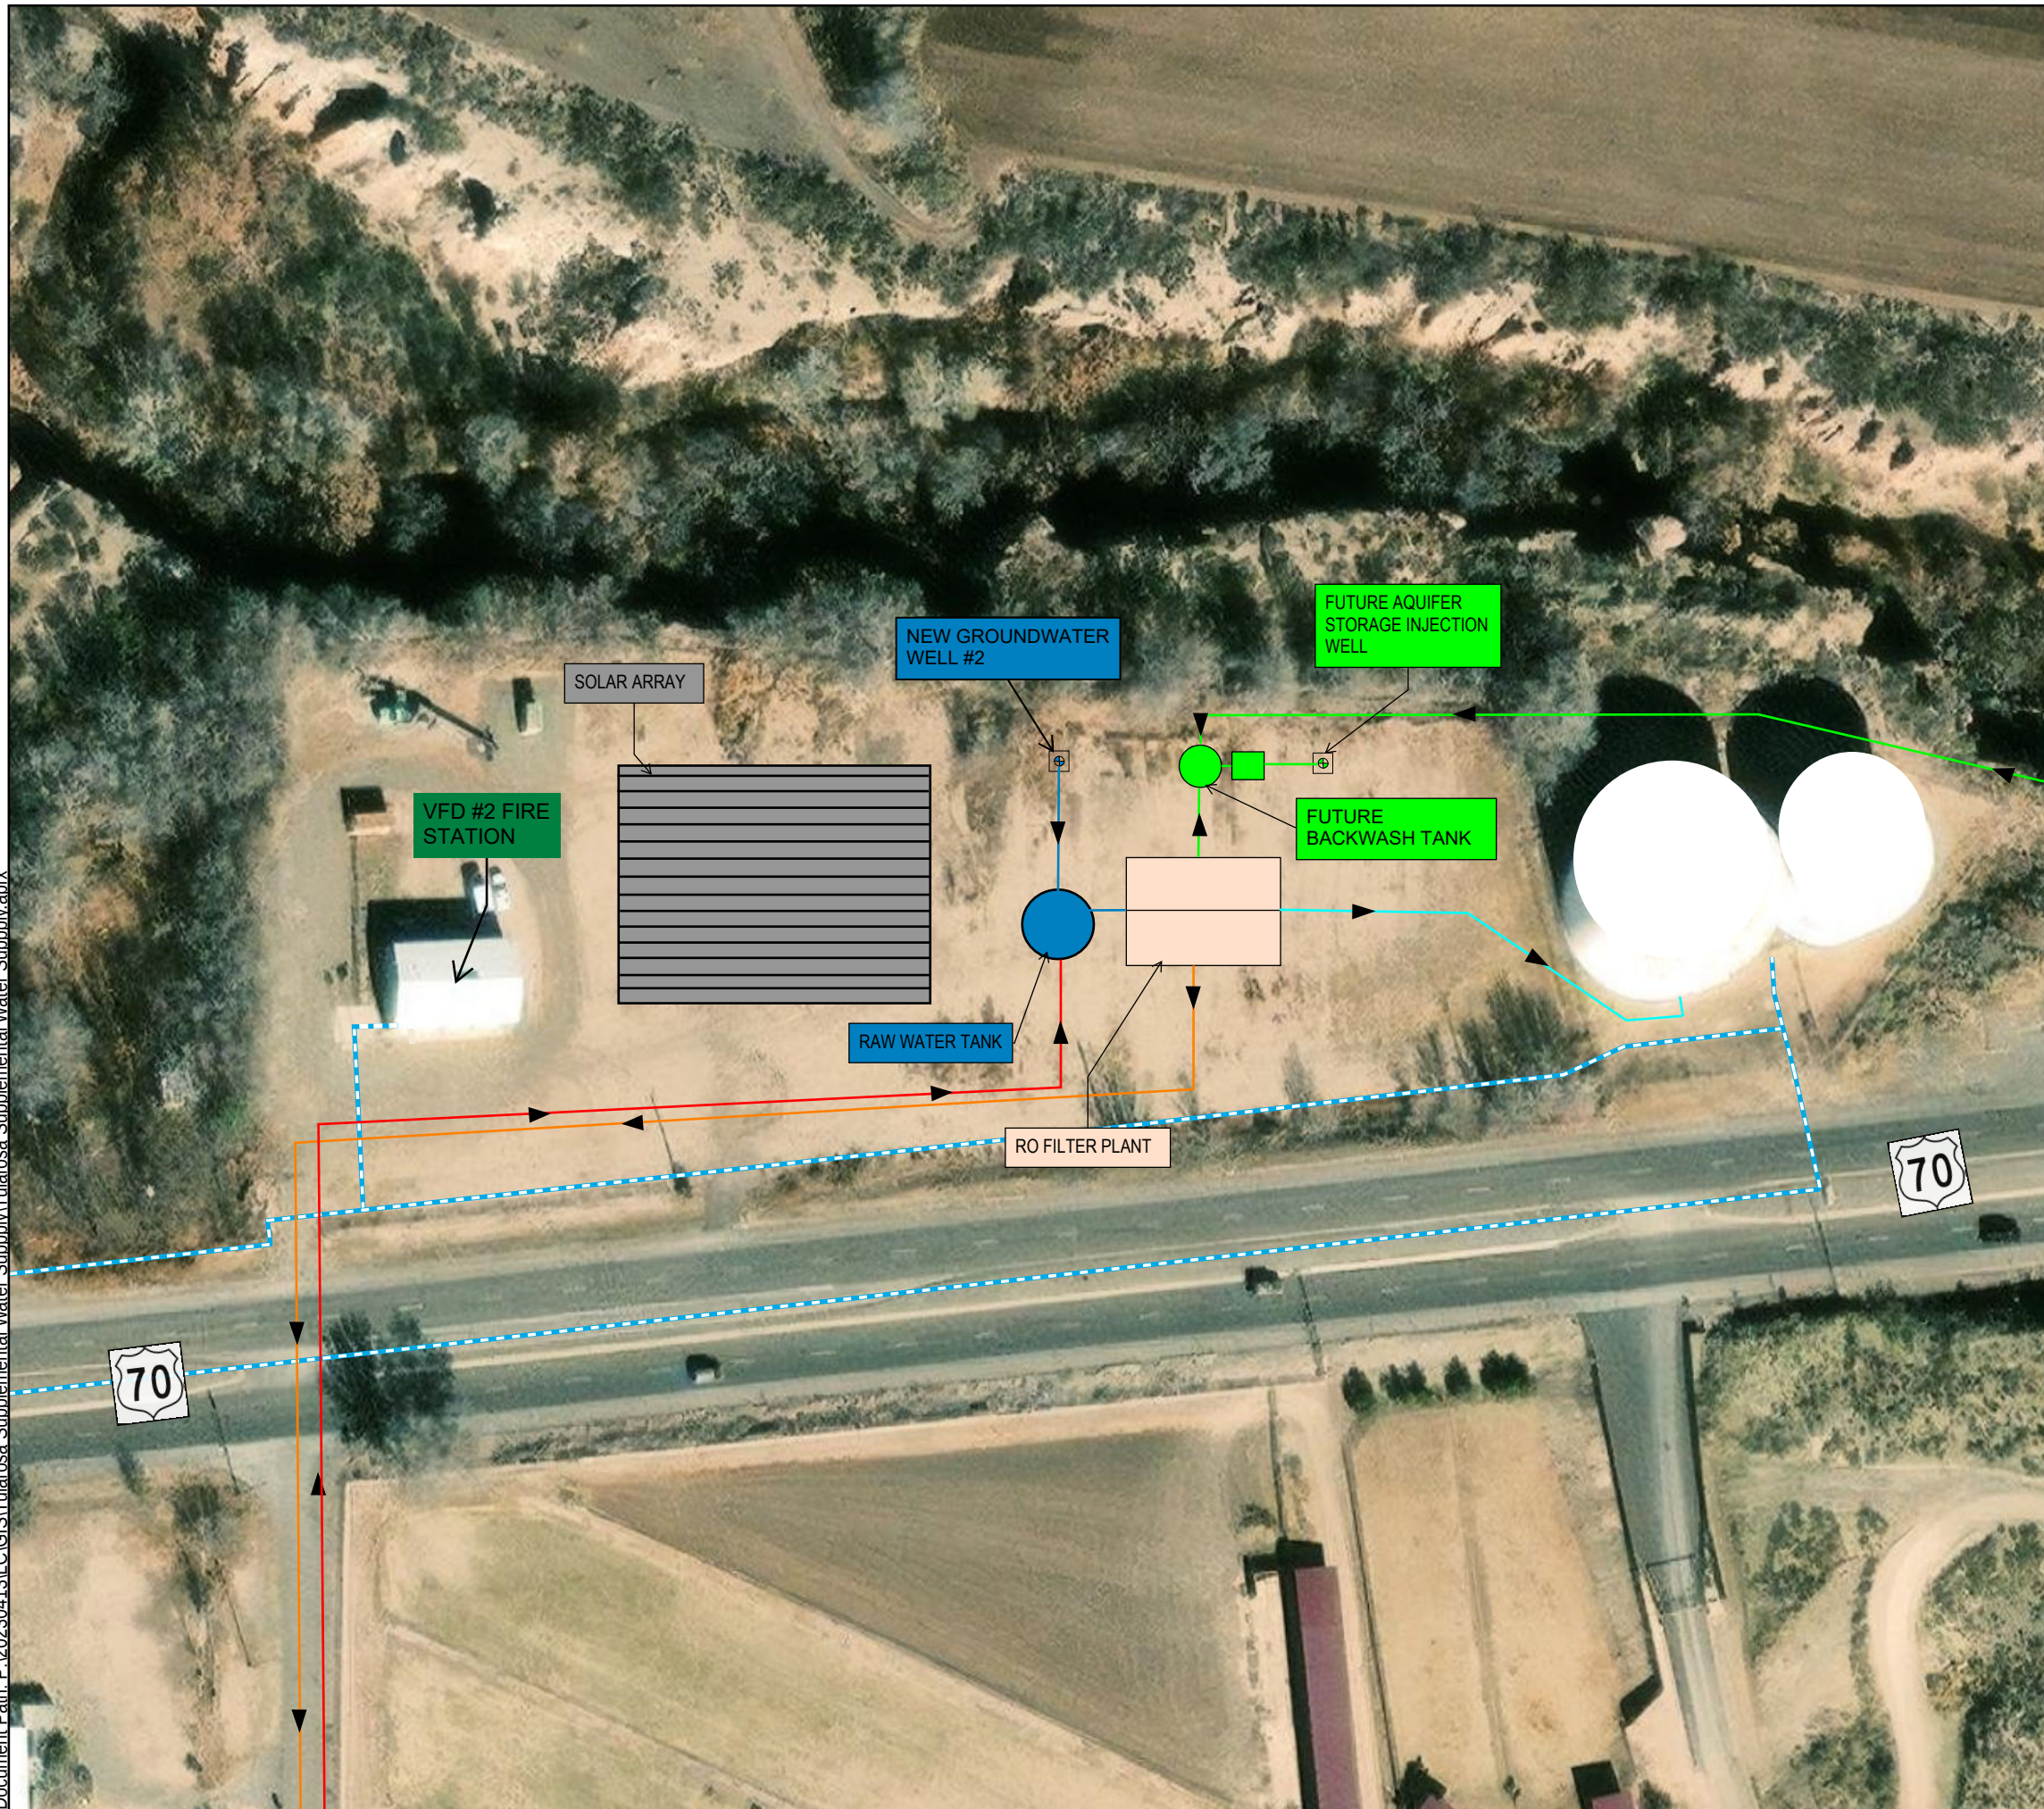
**Figure 5**  
**Village of Tularosa**

- Existing Distribution Line
- Raw Water - Montezuma Well
- RO Rejected to Evaporation Ponds
- Backwash Water
- Finished Water

Supplemental Water Supply  
**Proposed Reverse Osmosis  
Facilities**

- Transmission line from the Montezuma well that will supply the RO facility while the new groundwater well is drilled.
- New Groundwater Well: A new well will be drilled in this area to supplement the village's groundwater supply. Also, this new groundwater well is intended to be a replacement for the existing Montezuma well.
- New Raw Water Tank: A new tank will be constructed to store raw water extracted from the groundwater well before it is treated at the Reverse Osmosis (RO) facility.
- New Solar Array: To support the energy requirements of the groundwater extraction, treatment, and storage systems, a solar array will be installed, providing a renewable energy source to reduce electricity costs.
